NAVAL AVIATION SAFETY CENTER

Subj: NATC Patuxent River AAR ser 7-60 concerning A4D-2N BuNo 145072,  
accident occurring 25 October 1960, pilot (b) (6)

# DAMAGED AIRCRAFT CONDITION AND DISPOSITION REPORT NAVAER-2980 (REV. 4-55)

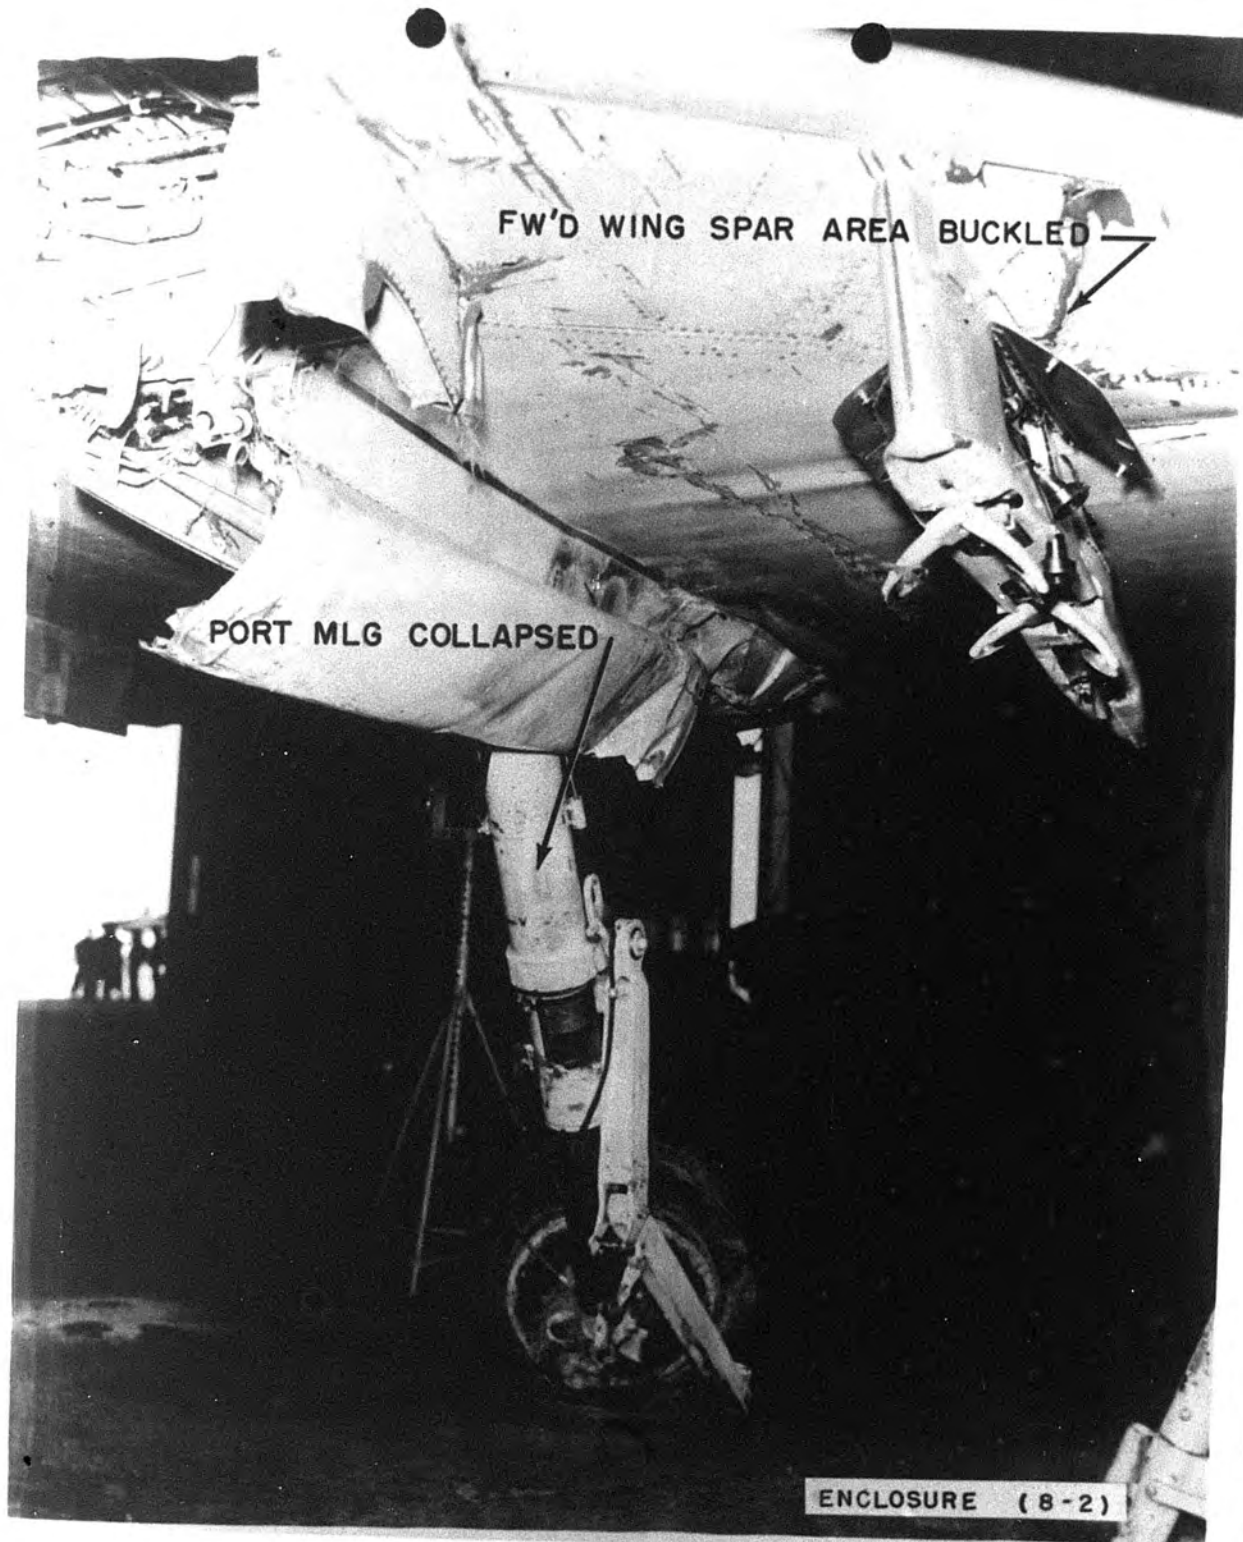
FW'D WING SPAR AREA BUCKLED

PORT MLG COLLAPSED

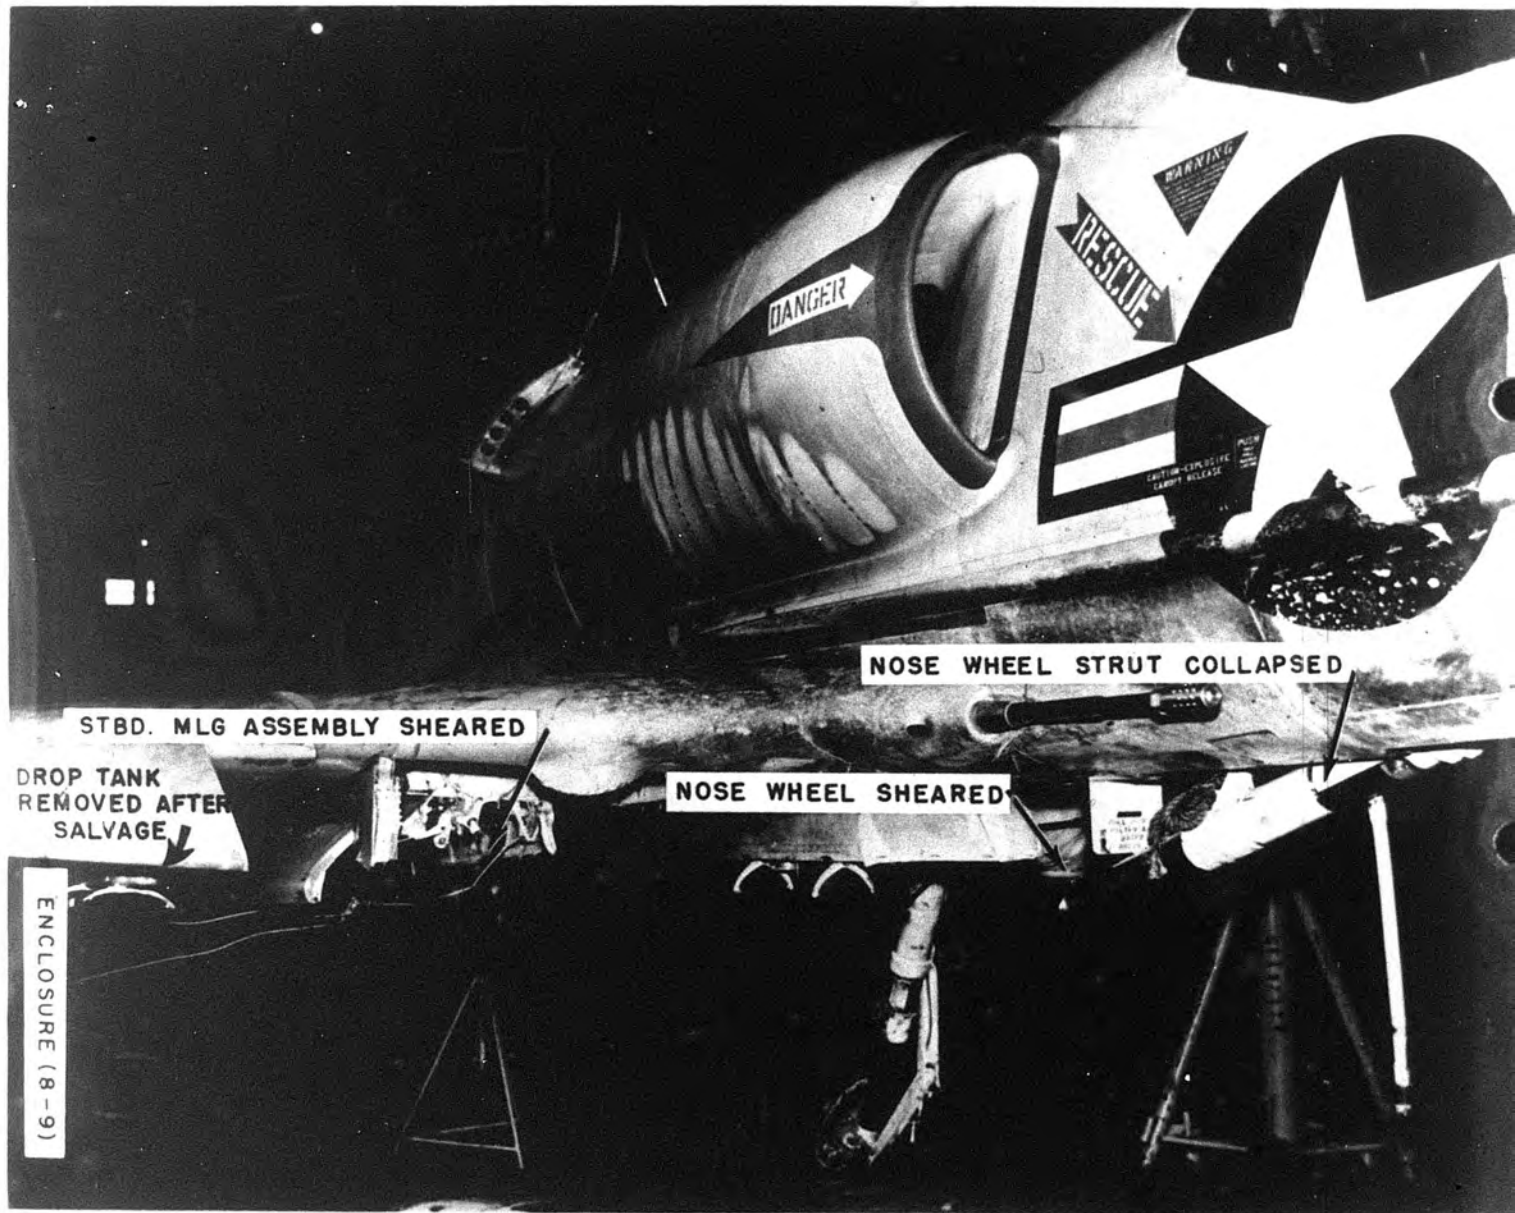
ENCLOSURE (8-9)

NOSE WHEEL SHEARED

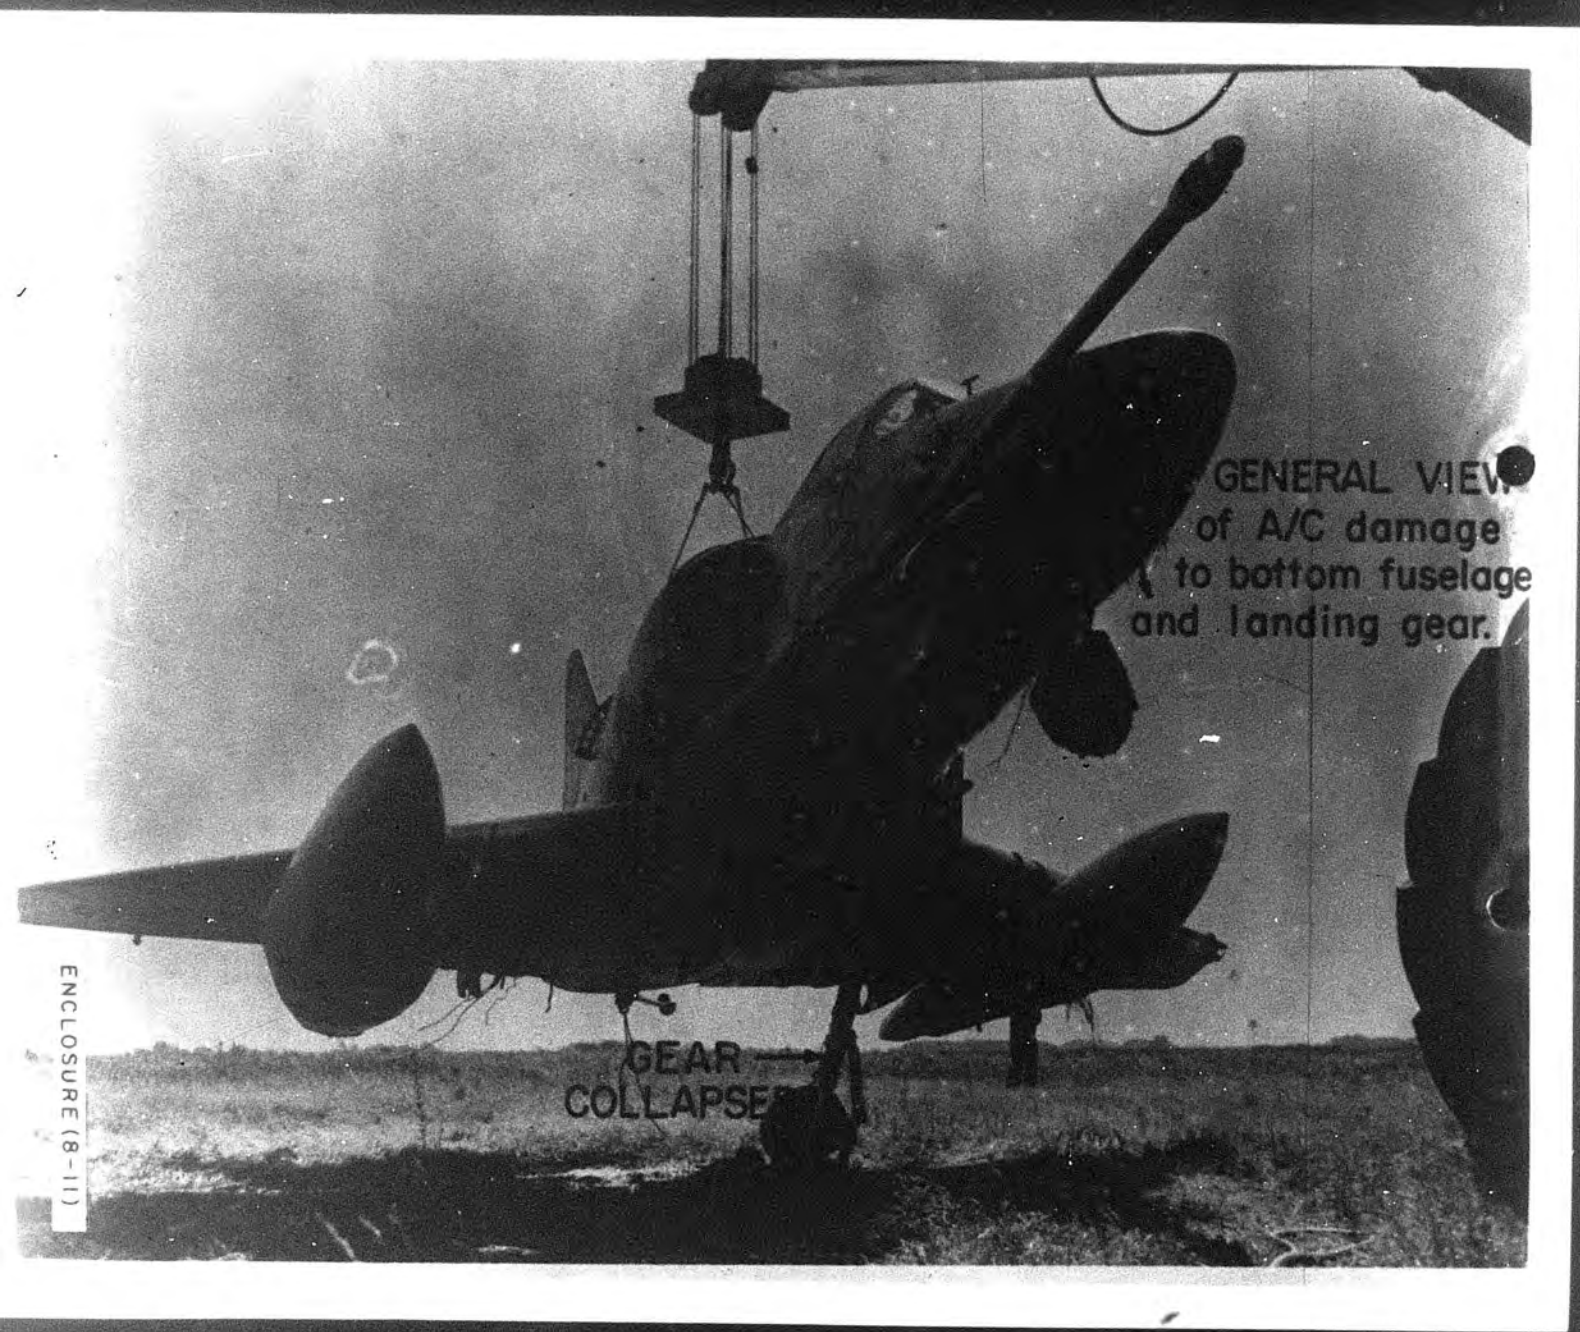
GENERAL VIEW  
of A/C damage  
to bottom fuselage  
and landing gear.

GEAR  
COLLAPSED

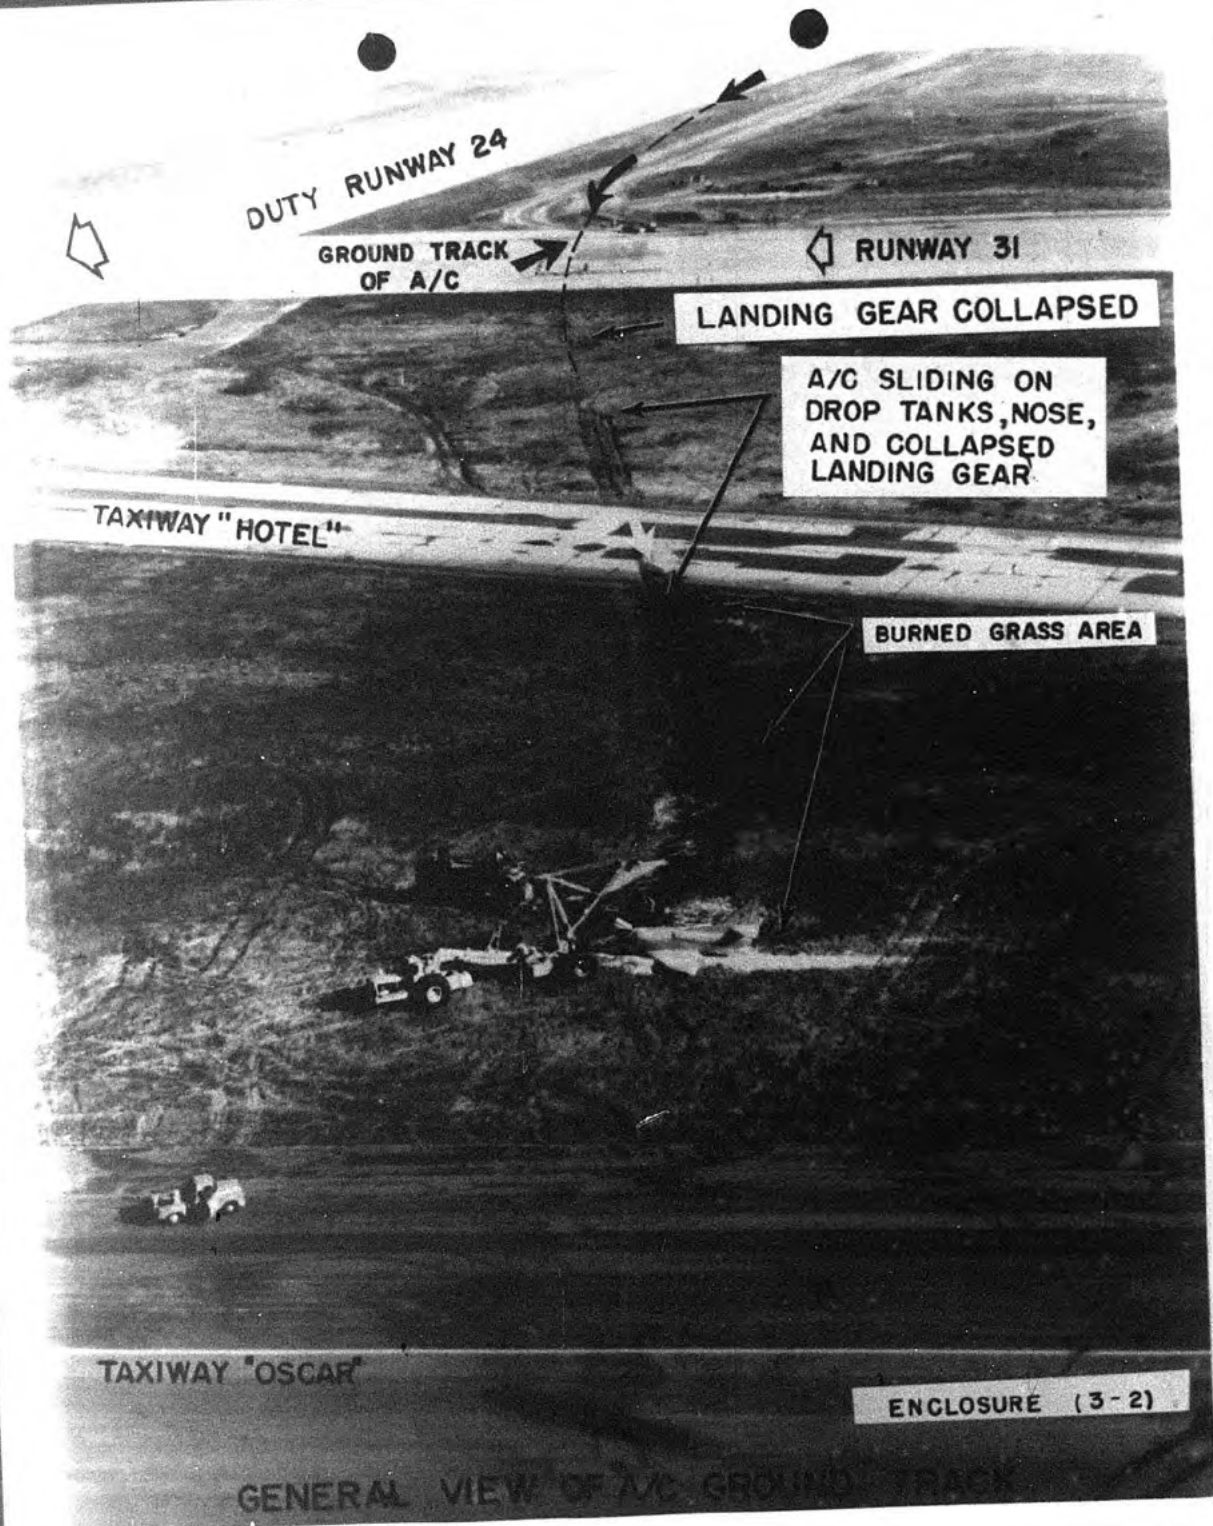
DUTY RUNWAY 24

GROUND TRACK  
OF A/C
